13 January 1959

Suggested Modification to the [REDACTED] Receive Data Terminal -  
Submitted by [REDACTED]

REF : TASK III, [REDACTED] Schematic of Control Drawer, Receive Data, Drw #322431

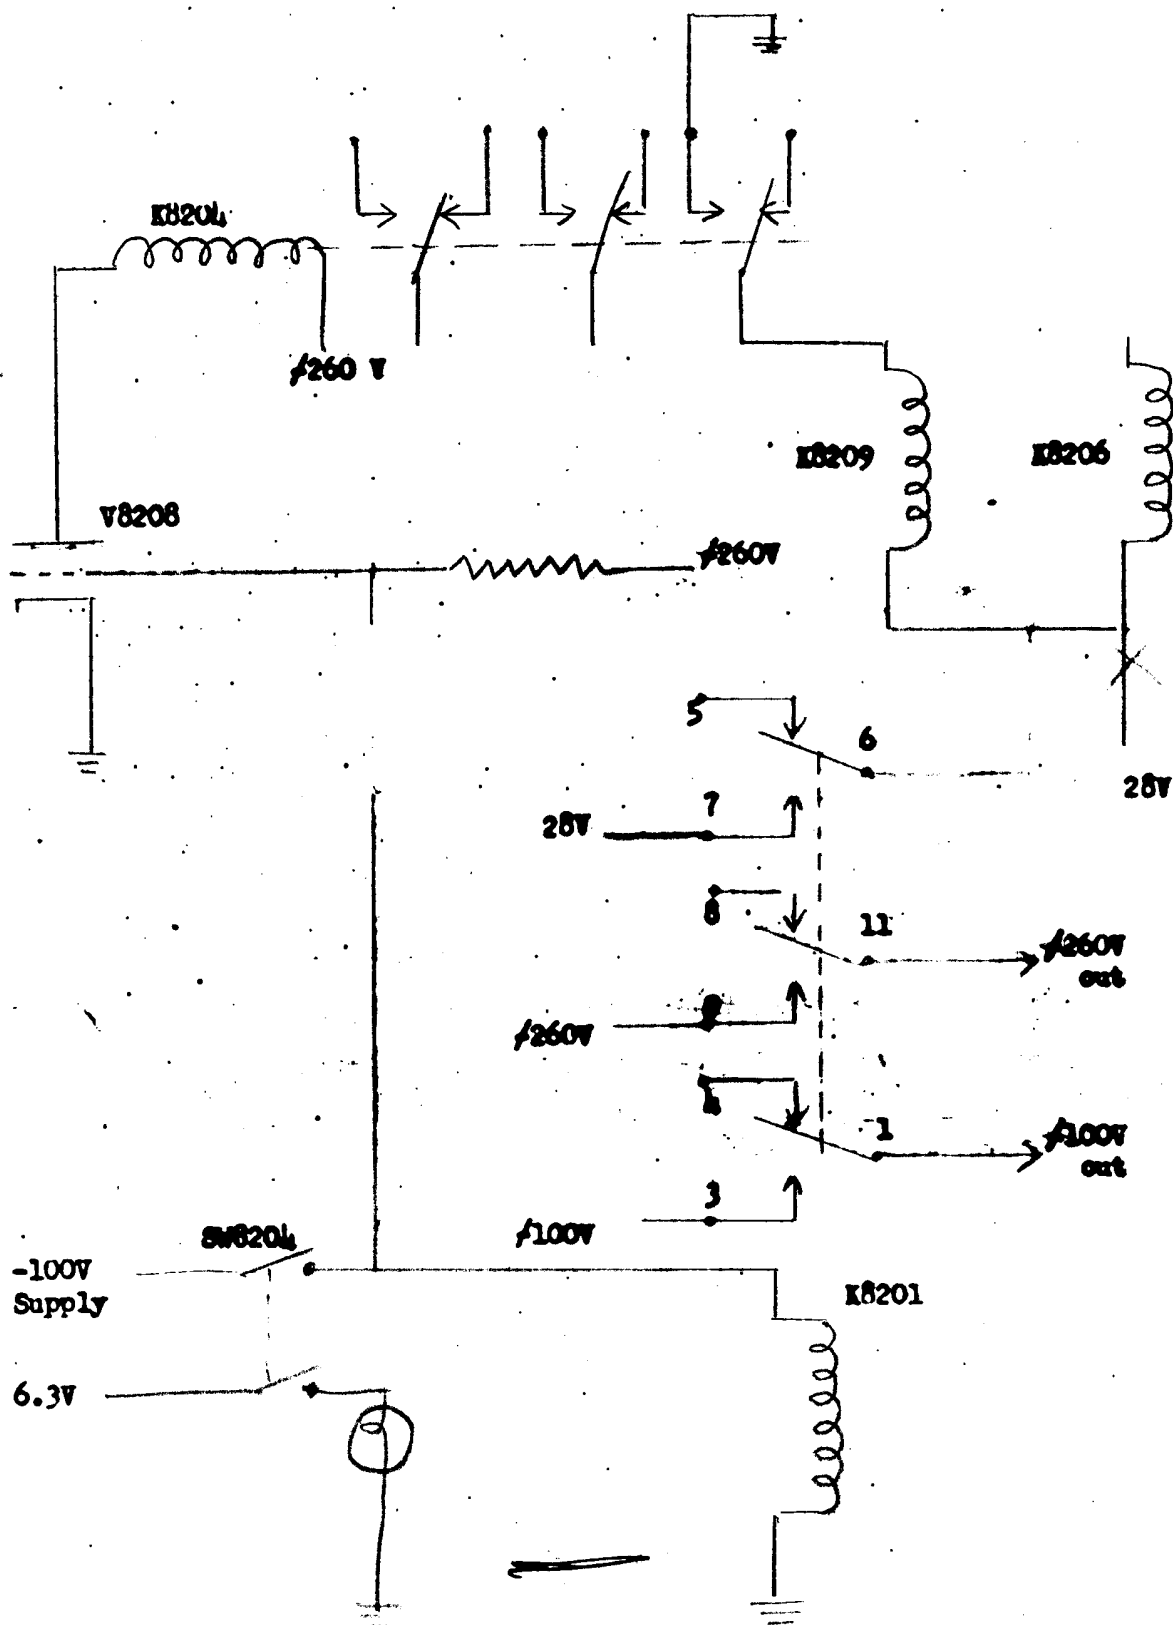
**Enclosure:**  
Schematic

1. It has been noted that the Soroban Reperforator motor can be started by loss of -100 volts in the terminal. Due to the high cost of the Soroban and difficulty in obtaining replacements and repairs, it would seem necessary to take all precautions to prevent excessive running and damage to the unit. With the Receive Data terminal in the AUTO or SEMI-AUTO position, the Receive Data terminal supposedly can and will be left unattended. At such times the Soroban motors should not be operating. However, if the -100 volt supply should blow a fuse or in some other way lose power, then the Soroban motor will automatically start and continue to operate until manually stopped.

2. The reason for this condition is due to the time lag from the loss of -100 until the loss of the other power supply voltages. The -100 voltage operates relay K8201, which, through its contacts, completed the circuits for the /260 and /100 to all chassis. In time sequence of operation this means that -100 is lost first and some time later, depending on the residual holding time of relay K8201, the /260 and /100 are lost.

3. The Transmission Start Relay tube V8208 (see attached simplified schematic) uses -100 for bias and plate voltage supply /260. As a result of losing the bias, the tube will conduct and operate Start Relay K820 which in turn energizes Secondary Relay K8209 and Reperforator Motor Relay K8206 and starts the Reperforator Motor. This condition on V8208 is short-lived but K8209 and K8206 have already operated and will remain energized as long as +28 volts is available or until the Reperforator STOP button is manually pressed.

4. A suggested possible cure for this condition would require a slight wiring modification and utilizing available contacts on K8201. As shown on the attached schematic, the /28 volts supply for relay K8209 and K8206 would be connected through relay K8201 contacts Nos. 6 and 7. With this modification, when-

ever -100 is lost, it will also open the source of 28 volts for re-  
lays K8206 and K8209 and therefore prevent operation of the Reper-  
forator Motor.

Note; Modification shown in RED
